Manhole Inspection Summary

Manhole # S33UU1020MH

Insp Date: **3/19/07 9:32 AM**

Location Address: **5001 SPRINGLAKE WAY**

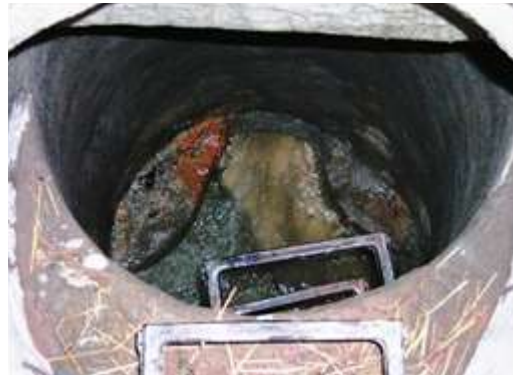
Top View

Frame Offset: **0** (in.) Condition: ☐ Sound ☐ Cracked ☒ **Leaks**

Infiltration: ☐ None ☒ **Joint** ☐ Cracks ☐ Mortar ☐ Roots ☒ **Wall**

Infiltration: ☐ None ☐ Joint ☐ Cracks ☐ Mortar ☐ Roots ☒ **Wall**

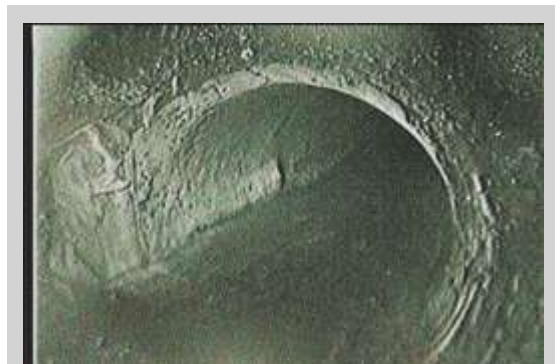
Pipe Out @ 12 O'Clock

15 in. Circular Gravity Sewer

☒ Pipe Lined

Invert Depth: **13.15** (ft.) Flow Characteristics: **Fast**

Infiltration: **None**

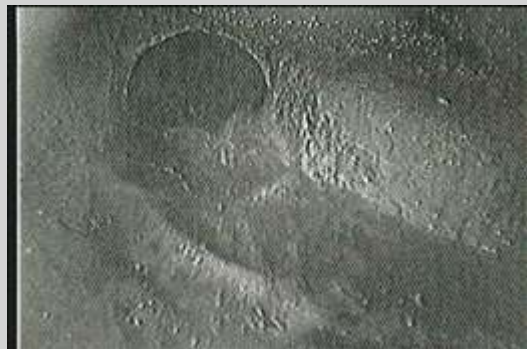
Pipe In @ 8 O'Clock

10 in. Circular Gravity Sewer

Infiltration: **None**
